HYDRAULIC SYSTEMS

INSTALLATION INSTRUCTIONS. 10 STEP CLUTCH RELEASE BEARING & SLAVE CYLINDER ASSEMBLY FITTING

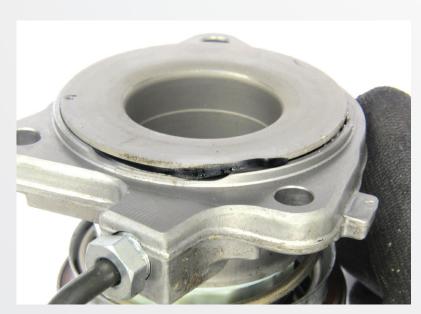
Do not compress the clutch release bearing & slave cylinder assembly prior to fitting.

Clutch release bearing and slave cylinder assembly's internal seal losing integrity resulting in leakage of hydraulic fluid.

damage caused

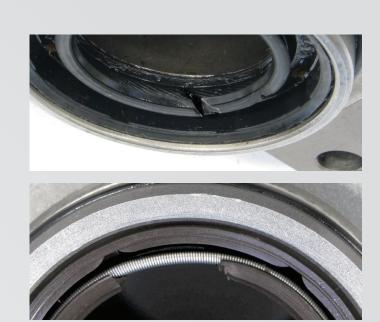
Ensure that the external seal of the clutch release bearing & slave cylinder assembly (where present) is not damaged when it is moved over the gearbox input shaft.

Gearbox oil will leak past the external seal resulting in swelling of clutch release bearing & slave cylinder assembly's internal seals and failure.

damage caused

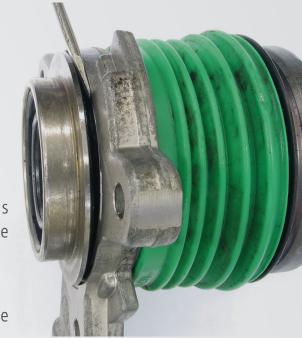
Ensure that the clutch release bearing & slave cylinder assembly mounting surface is flat with the gearbox receiving surface. Ensure that the bolts are "finger tight" before tightening to the correct torque as specified by the vehicle manufacturer.

Unleveled mounting, causing clutch release bearing & slave cylinder assembly's sleeve to move backwards resulting in leakage of hydraulic fluid and failure.

damage caused

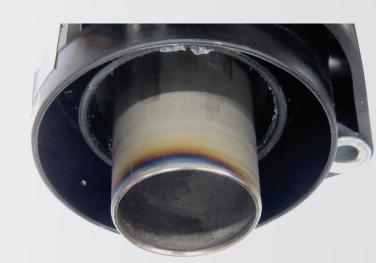
Ensure that the clutch plate is mounted the correct way round to the vehicle manufacturers specifications.

Clutch release bearing & slave cylinder assembly's sleeve will foul on the clutch plate spline causing failure.

damage caused

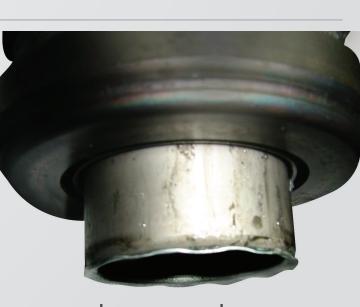
Follow the car manufacturers recommended bleeding instructions and use recommended bleeding devices. Warning: Do not bleed manually while using bleeding devices. Warning: If bleeding manually do not pump up the system by repeatedly depressing the clutch over a short period of time.

Over-stroke results in the clutch release bearing & slave cylinder assembly leaking hydraulic fluid or bursting.

damage caused
